INDOOR AIR QUALITY ASSESSMENT

**High Rock School
77 Ferndale Road
Needham, Massachusetts**

Prepared by:
Massachusetts Department of Public Health
Center of Environmental Health
Emergency Response/Indoor Air Quality Program
June 2006

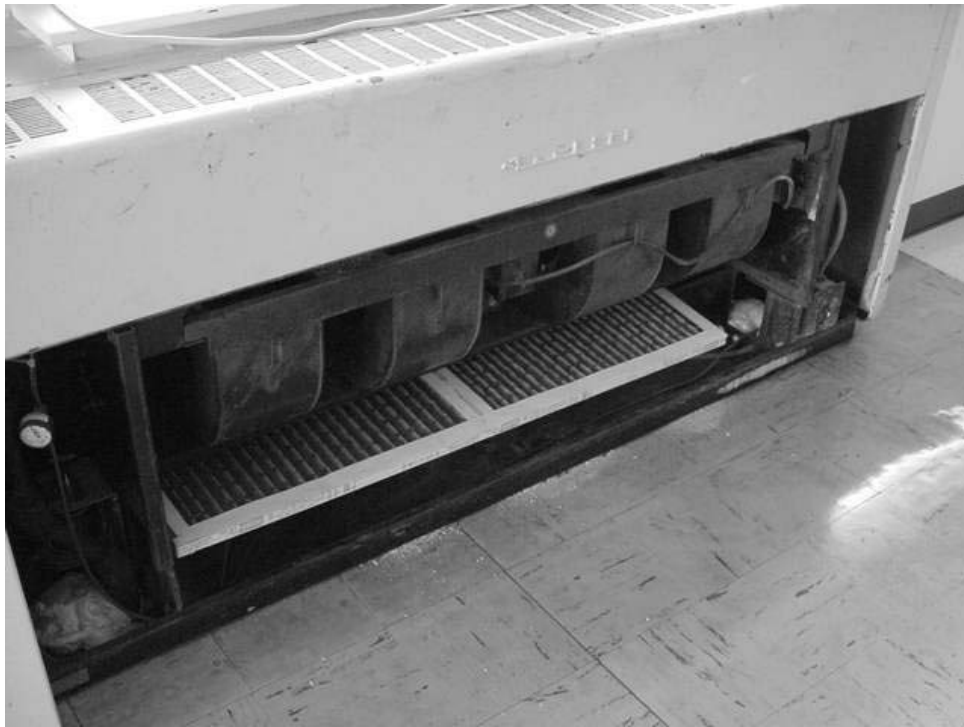
Picture 1

Fresh air in classrooms is supplied by a unit ventilator (univent) system (Picture 1). Univents draw air from outdoors through a fresh air intake located on the exterior walls of the building and return air through an air intake located at the base of each unit ([Figure 1](#)). Fresh and return air are mixed, filtered, heated and provided to classrooms through a fresh air diffuser located in the top of the unit. At the time of the assessment, univents were

Univent

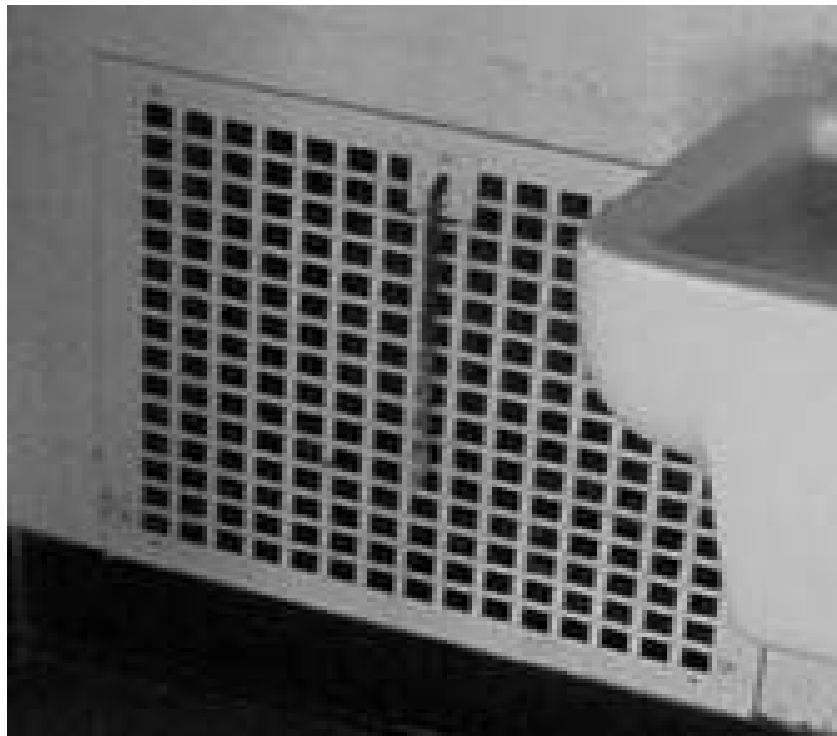
Picture 2

The mechanical exhaust system consists of wall-mounted vents. Airflow into these vents is controlled by an adjustable flue that is connected to a pull chain (Picture 2). A number of rooms were missing pull chains (Picture 2A), rendering the exhaust vents shut. Exhaust vents need to be opened to remove pollutants from the indoor environment.

Exhaust Vent with Chain in Place

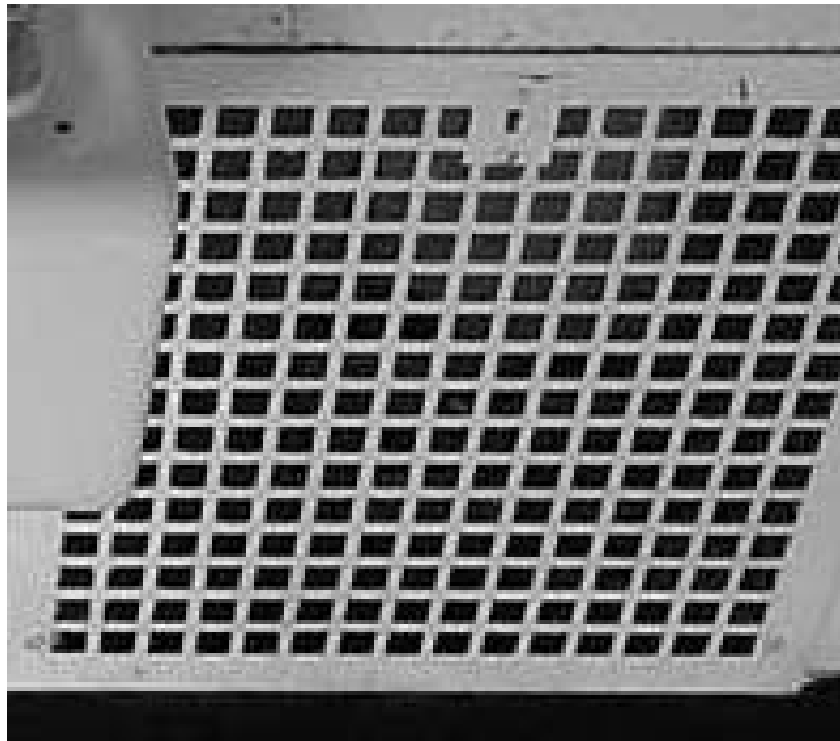
Picture 2A

Exhaust Vent, Note Chain Missing From Notch, Indicating Closure of the Louver

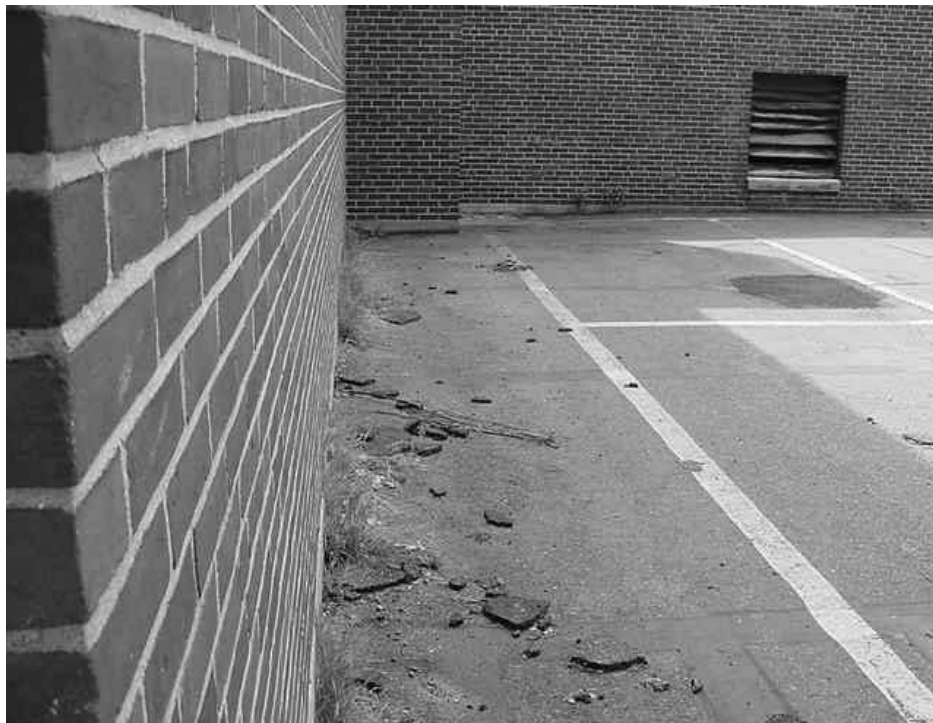
Picture 3

In the rear of the HRS is a tarmac/courtyard ([Map 2](#)). It appears that part of the tarmac slopes *towards* the west wall of the cafeteria (Picture 3). Opportunities for water penetration through the building envelope were observed along the exterior wall/tarmac junction of the gymnasium/cafeteria wing and other areas of the school. Plants were noted growing in the junction between the exterior wall and the tarmac (Picture 4). Shrubbery growing immediately adjacent to the exterior wall brick was noted along the building foundation (Picture 5). Plants/shrubbery growing directly against the building can serve as a possible source of water impingement on the exterior curtain wall. These conditions can produce means for water to penetrate below grade areas, such as basements and crawlspaces. In some cases, roots can work their way into mortar and brickwork causing cracks and fissures. Over time, this process can undermine the integrity of the building

Tarmac Outside Cafeteria Sloped towards the Exterior Wall

- 6) Examine the feasibility of reestablishing the slope of the tarmac surface of the courtyard to drain rainwater away from the exterior wall of the cafeteria.

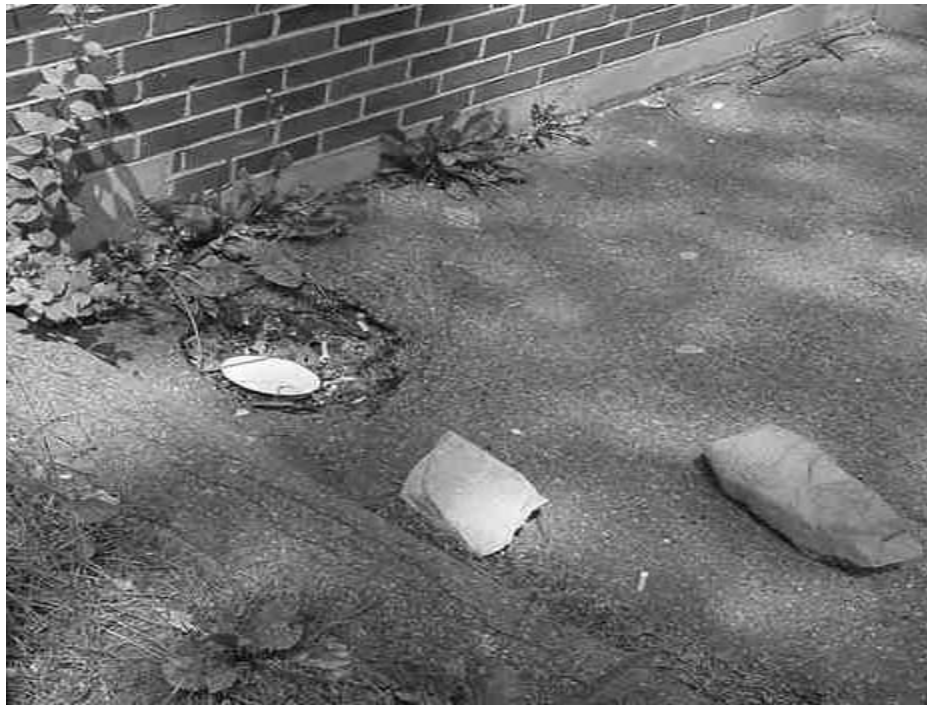
Picture 4

**Example of Plants Growing in the Junction between the Exterior Wall and the Tarmac,
Note Holes and Cracks in Tarmac.**

- 7) Remove all vegetation from the exterior wall/tarmac seam and seal all joints around the building.
- 8) Reseal holes and cracks in tarmac (Picture 11) and wall/tarmac junction with a water impermeable sealant.

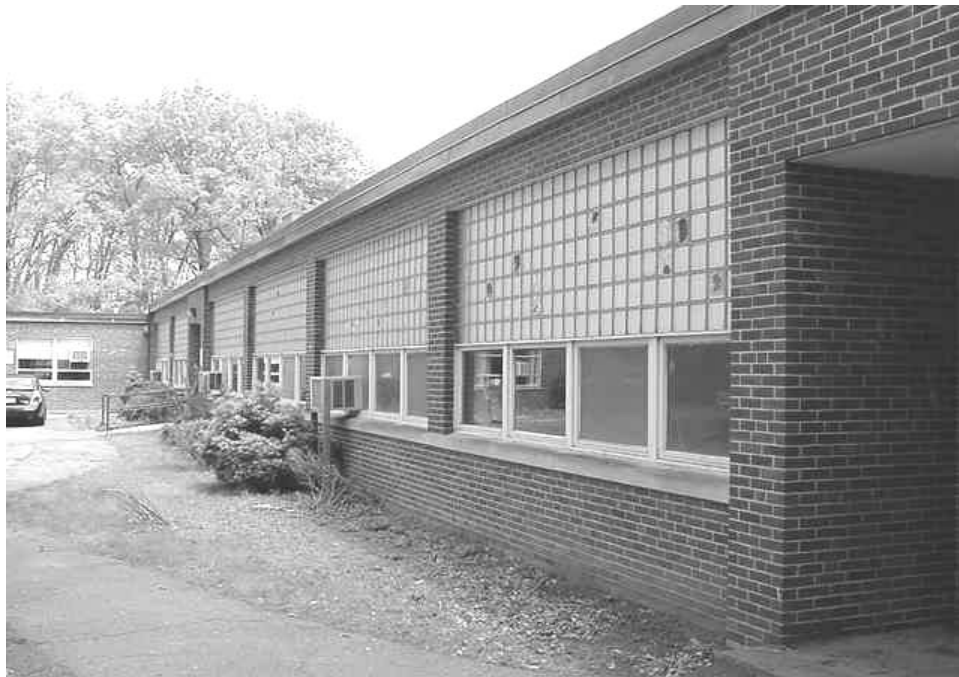
Picture 5

Shrubbery along Edge of Exterior Wall

- 5) Take steps to prevent prolonged moisture contact with the foundation. These steps may include:
 - a) Removing foliage, gardens and mulch to at least five feet away from the foundation.

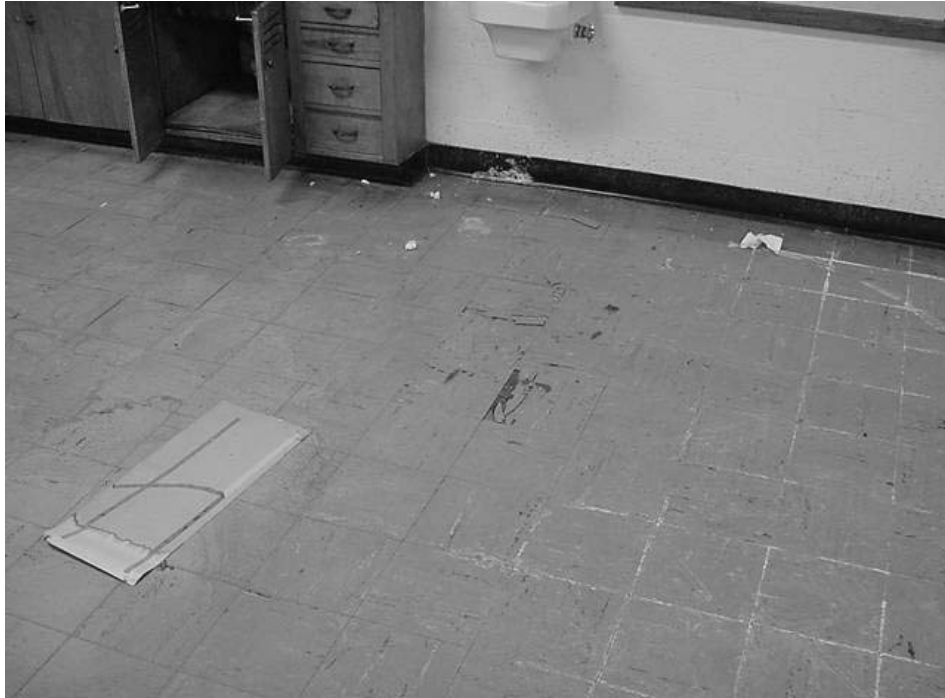
Picture 6

Damaged floor tile was also noted in room 15 (Picture 6). Of significance is the location of a retrofitted accessibility ramp that exists along the western exterior wall of the HRS (Picture 7). The exterior door connected to the accessibility ramp is covered by a peaked roof that does not have a gutter/downspout system. Half of the peaked roof directs water to a cement-lined pit at the base of the exterior wall. This type of structure is typically used to provide natural ventilation for crawlspaces. It is important to note that the pit is roughly aligned with the damaged floor tile in room 15. It is likely that the heavy rains of the past several months resulted in water penetrating into the crawlspace through this vent creating the tile damage.

As noted by school department staff, the damaged tile in room 15 contains asbestos and should be properly remediated in a manner consistent with asbestos abatement laws. At the time of the assessment, the room where these tiles were located was not accessible to children in the building and therefore does not likely to pose a health concern unless further breakage or pulverizing of the tile occurs. Needham school officials reported plans to repair the damaged floor tiles during the summer 2006 break.

Damaged Floor Tiles in Room 15

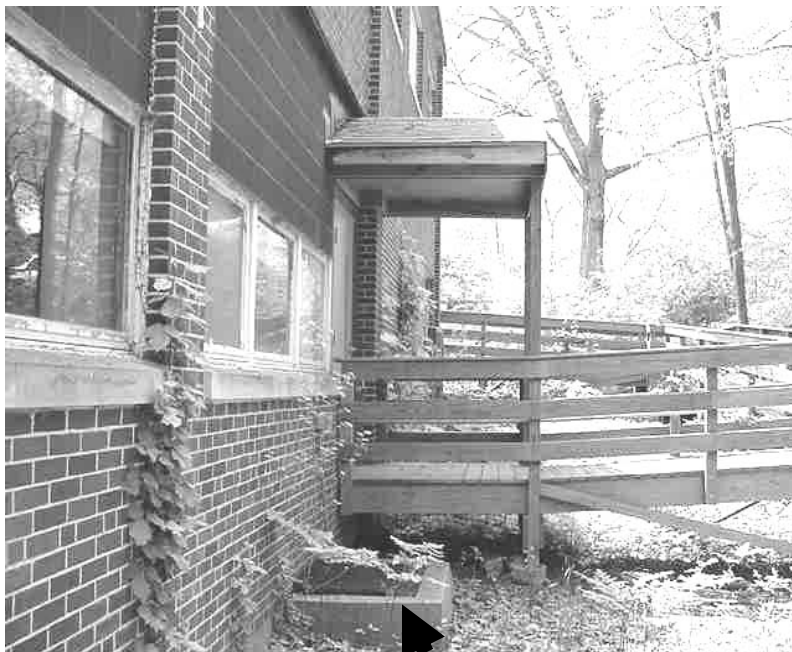
Picture 7

Crawlspace Vent

Roof over Access Ramp, Note no Gutter/Downspout on Roof Edge and the Cement Lined Crawlspace Vent beneath the Roof Edge.

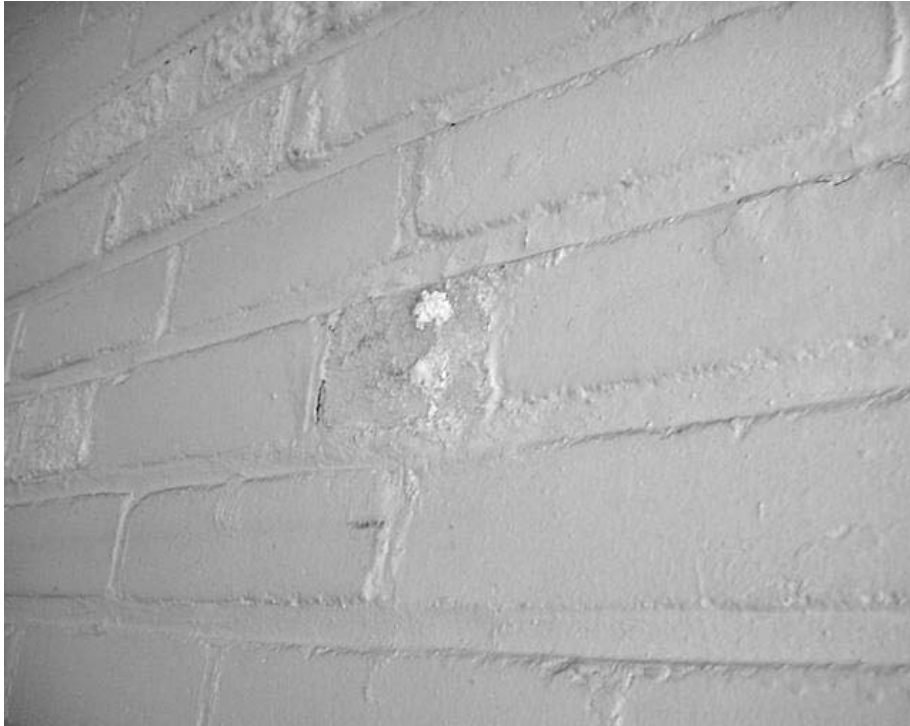
Picture 8

Efflorescence was observed on interior walls at the rear wall of the stage (Picture 8) and in one restroom. Efflorescence is caused by water penetration through brick, dissolving minerals within the brick as it flows through. The water evaporates leaving a dry white residue. While efflorescence is a characteristic sign of water penetration, it is not mold

growth. The presence of efflorescence can indicate that water is penetrating through the exterior wall system. Paint consists of carbon, which can serve as a mold growth medium. Because of the location of the efflorescence on the stage wall, it may be advisable to remove paint and leave the concrete bare in order to readily observe future water penetration.

Efflorescence on Rear Wall of Stage

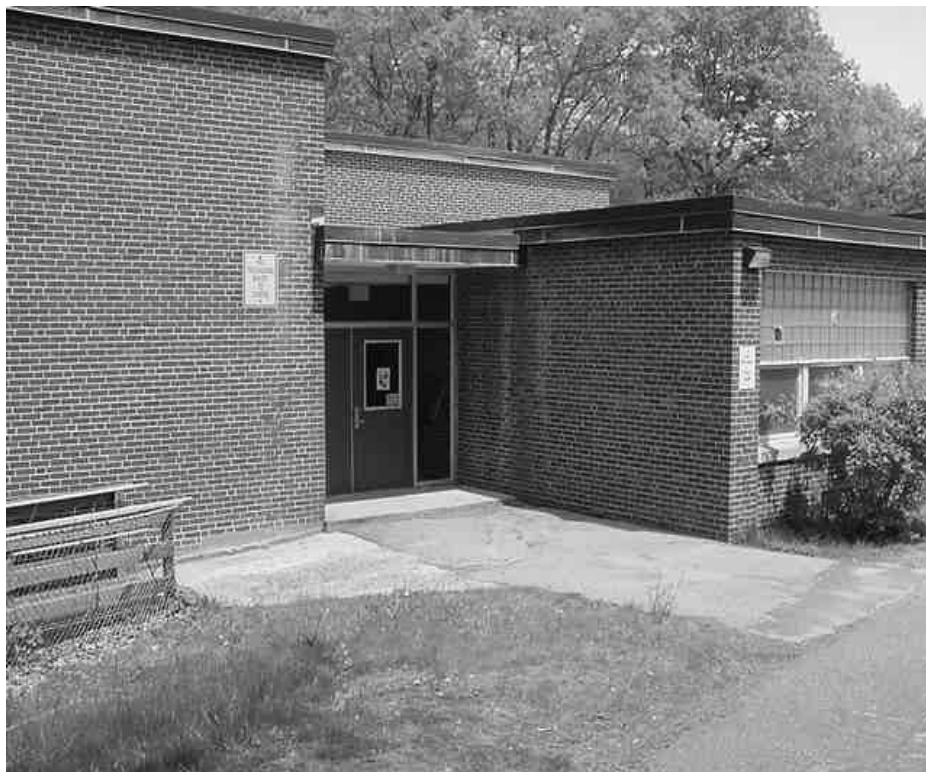
Picture 9

Water damage was noted on brickwork on the south exterior wall (Picture 9). A gutter/downspout system should be installed below the short roof/exterior wall junction to direct rainwater away from the building to prevent chronic water exposure to brickwork.

Water Damage to Exterior Wall from Roof Rainwater Run-Off

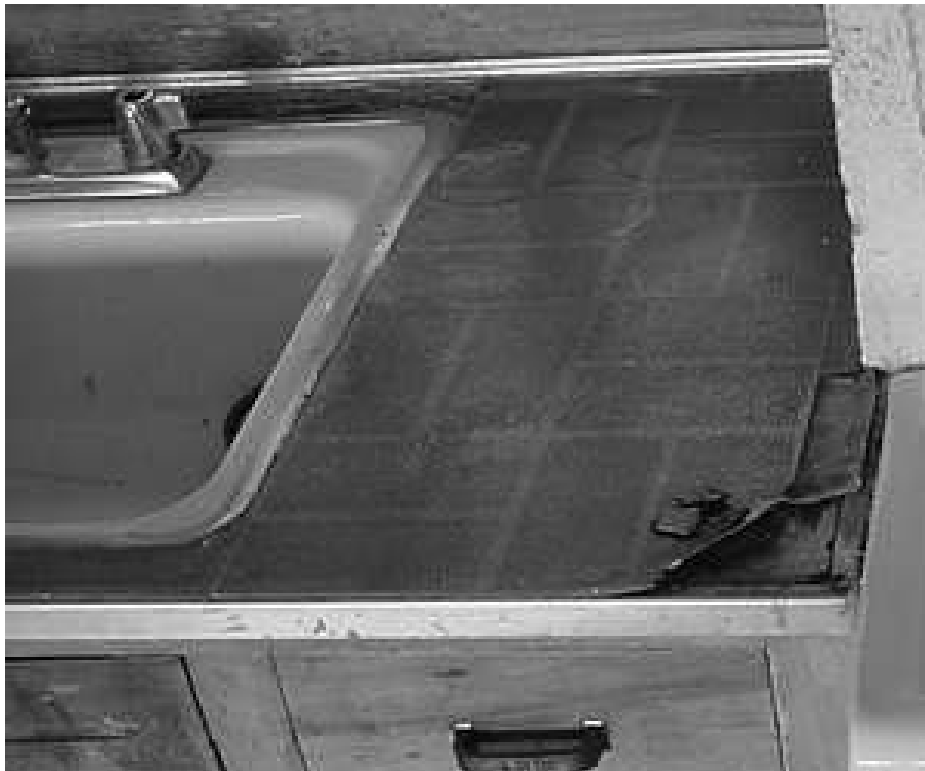
Picture 10

Several classrooms have sinks with a seam between the countertop and wall (Picture 10). If not watertight, water can penetrate through this seam. Water penetration and chronic moisture exposure can cause porous materials to swell and serve as a medium for mold growth.

Water Damaged Sink Top

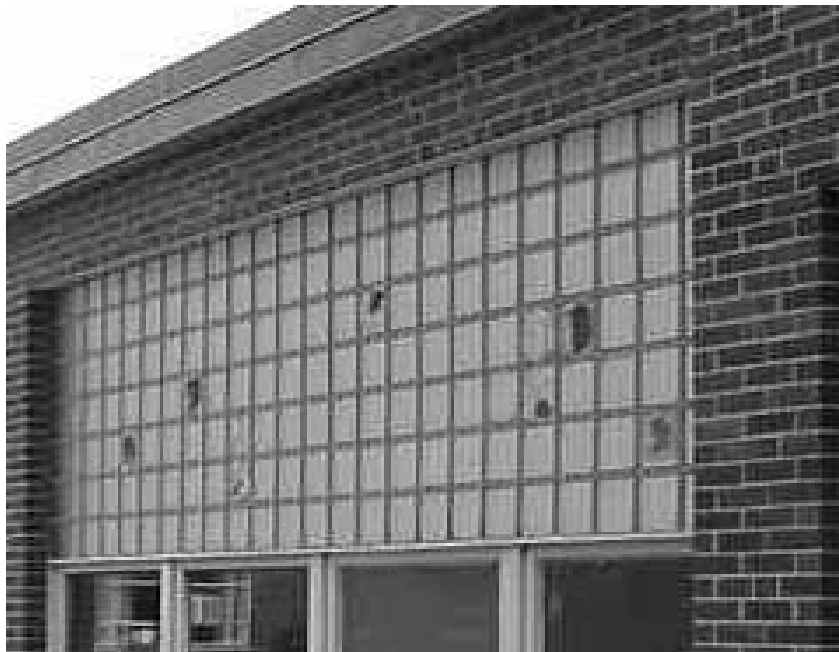
Picture 11

The building has a mixture of different window systems in classrooms. The majority of windows consist of fixed glass blocks with openable windows. In some classrooms, exterior surfaces of glass window blocks were either broken or cracked as a result of vandalism (Picture 11). The window system in each classroom with broken glass blocks was examined for water penetration. No water damage through the window system was identified. However, over time, damage to blocks can lead to water penetration and serve as a potential source of microbial growth. Standing water in these blocks can also stagnate, leading to bacterial growth and possible nuisance odors.

Damaged Glass Block Windows

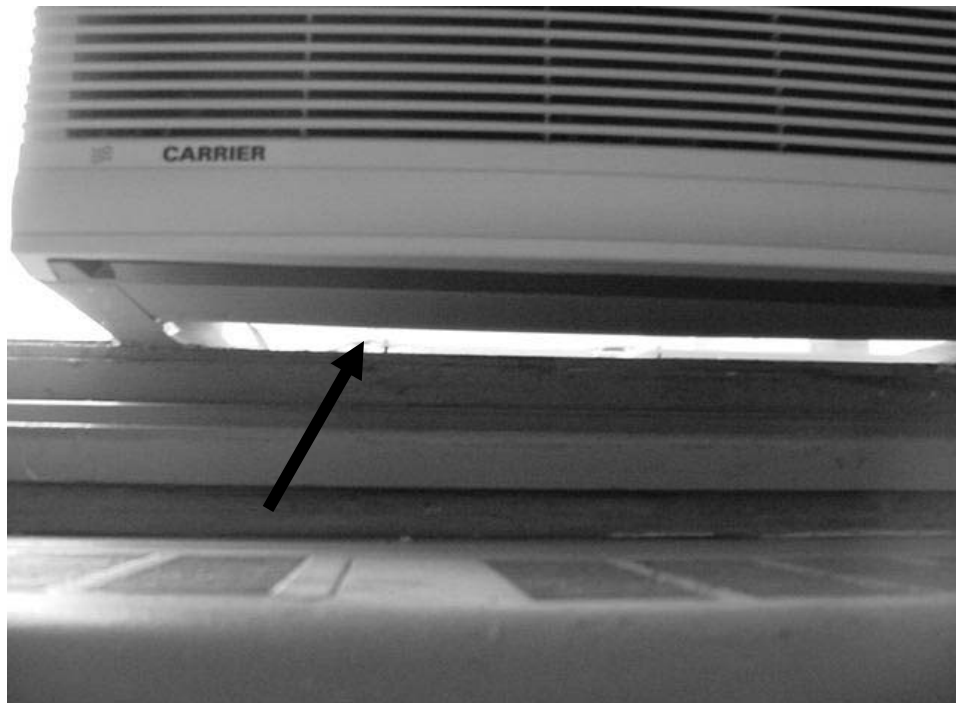
Picture 12

Installation of window mounted air conditioners (WACs) can provide a possible means for water penetration into the building. Spaces were seen around materials used to install WACs (Picture 12), which can allow water, drafts and insects into the building.

Space beneath Window-Mounted Air-Conditioner

- 9) Seal abandoned/unused water bubbler drains. If not already done, shut off water supply to abandoned bubblers to prevent accidental flooding.
- 10) Appropriately seal all spaces around window-mounted air conditioners.

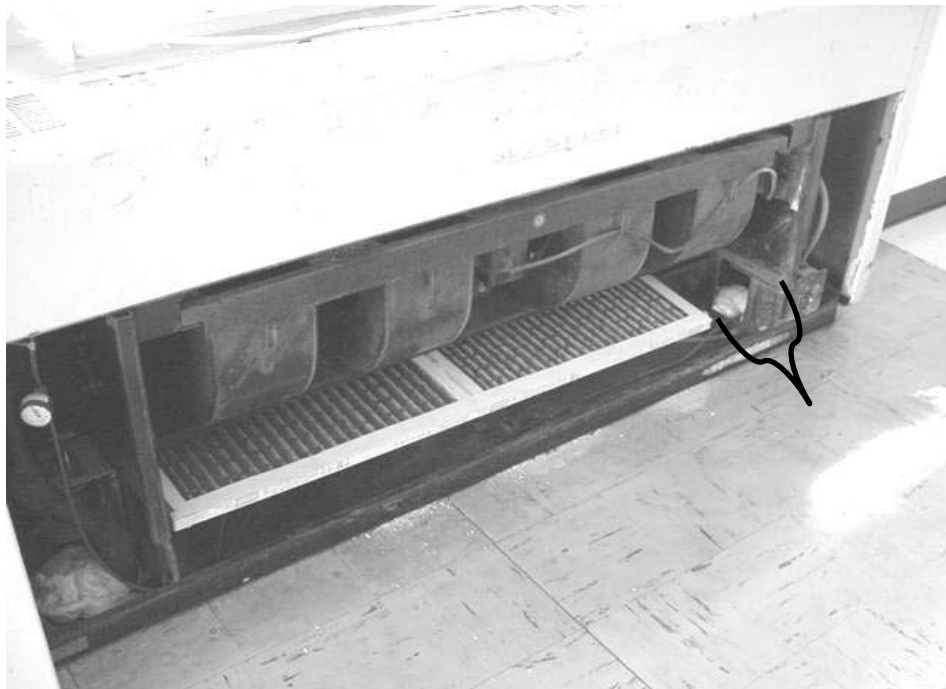
Picture 13

A filter installed in one univent was not the correct size for the unit (Picture 13). In addition, holes in the univent cabinet can allow for air to bypass the filter (Picture 14). In order to decrease aerosolized particulates, properly-fitted filters should be installed and all cabinet holes above the filter should be appropriately sealed. The dust spot efficiency is the ability of a filter to remove particulates of a certain diameter from air passing through the filter. Filters that have been determined by ASHRAE to meet its standard for a dust spot efficiency of a minimum of 40 percent would be sufficient to reduce airborne particulates (Thornburg, 2000; MEHRC, 1997; ASHRAE, 1992). Note that increased filtration can reduce airflow produced by increased resistance, or pressure drop. Prior to any increase of filtration, a ventilation engineer should evaluate each univent to ascertain whether it can maintain function with more efficient filters.

Short Filter Installed in Univent (Marker Indicates Space)

- 13) Ensure that filters in univent are the appropriate size for each univent. Each filter should fit flush within the filter rack.
- 14) For buildings in New England, periods of low relative humidity during the winter are often unavoidable. Therefore, scrupulous cleaning practices should be adopted to minimize common indoor air contaminants whose irritant effects can be enhanced when the relative humidity is low. Drinking water during the day can help ease some symptoms associated with a dry environment (throat and sinus irritations).
- 15) Examine the feasibility of repairing or replacing damaged glass block windows. Inspect and repair/replace caulking around window frames to prevent water penetration. Repair water damaged windowsills, walls and wall-plaster. Examine these areas for mold growth. Disinfect areas of water leaks with an appropriate antimicrobial.

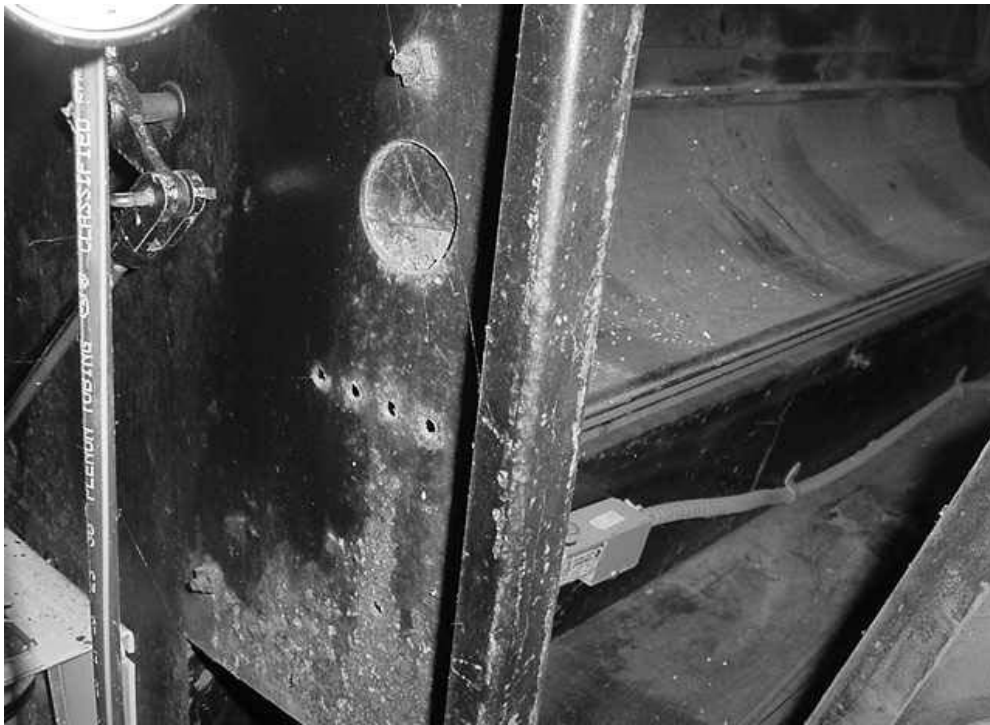
Picture 14

Holes in Univent Cabinet above Filter

- 11) Seal all holes in the walls of the univent air handling cabinets to limit filter bypass. Double sided, foil faced insulation with adhesive can be applied in a manner to create an airtight seal.

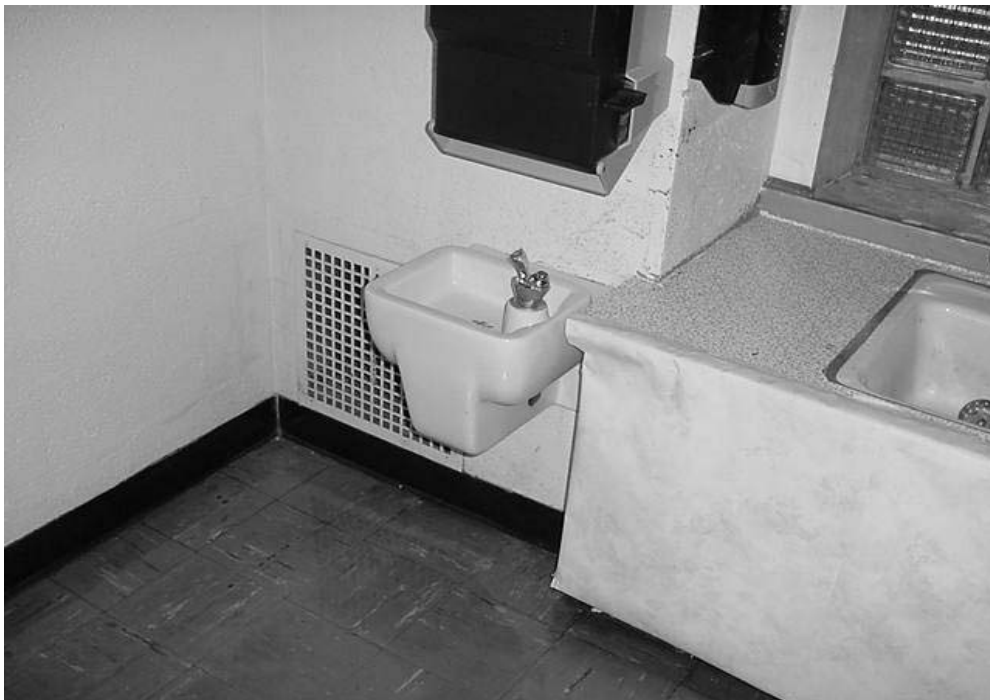
Picture 15

Classrooms have bubblers which are not used (Picture 15). It appeared that no water had been poured into these drains recently. Without draining water, the drain traps can dry, resulting in the loss of the airtight seal created by a wet trap. A dry trap can result in sewer gas backing up into the building under certain circumstances. In addition, the location of

these bubblers near classroom exhaust vents may result in odors being drawn into classrooms. Sewer gas can be irritating to the eyes, nose and throat.

Example of Bubbler Next To Exhaust Vent

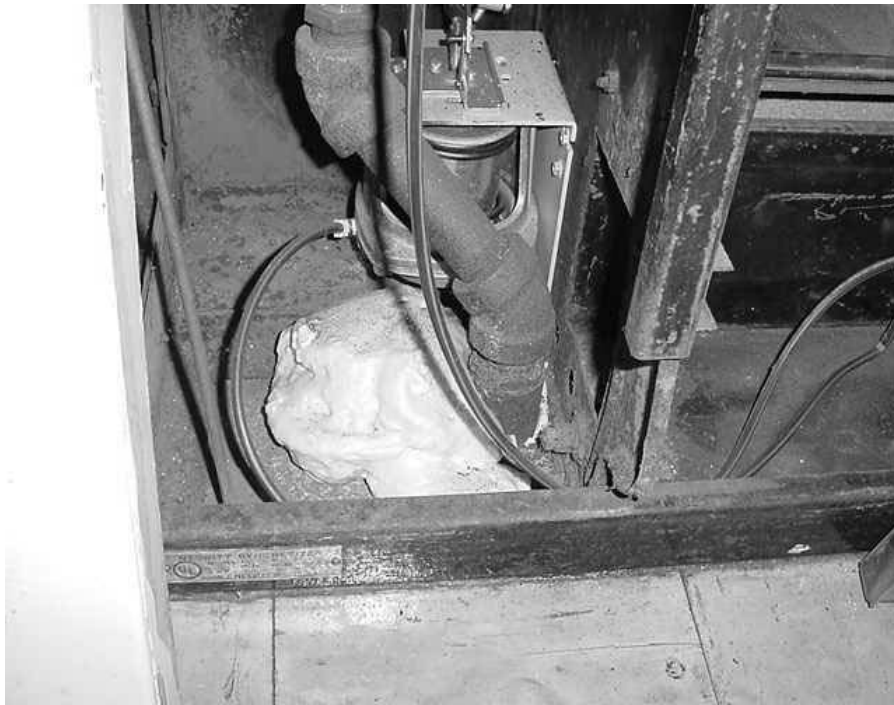
Picture 16

Foam Insulation Injected into Univent Utility Pipe Holes to Seal Classrooms from Crawlspace
